**RAVENSVIEW
WASTEWATER TREATMENT PLANT
2022 ANNUAL REPORT**

Ravensview Wastewater Treatment Plant Annual Report

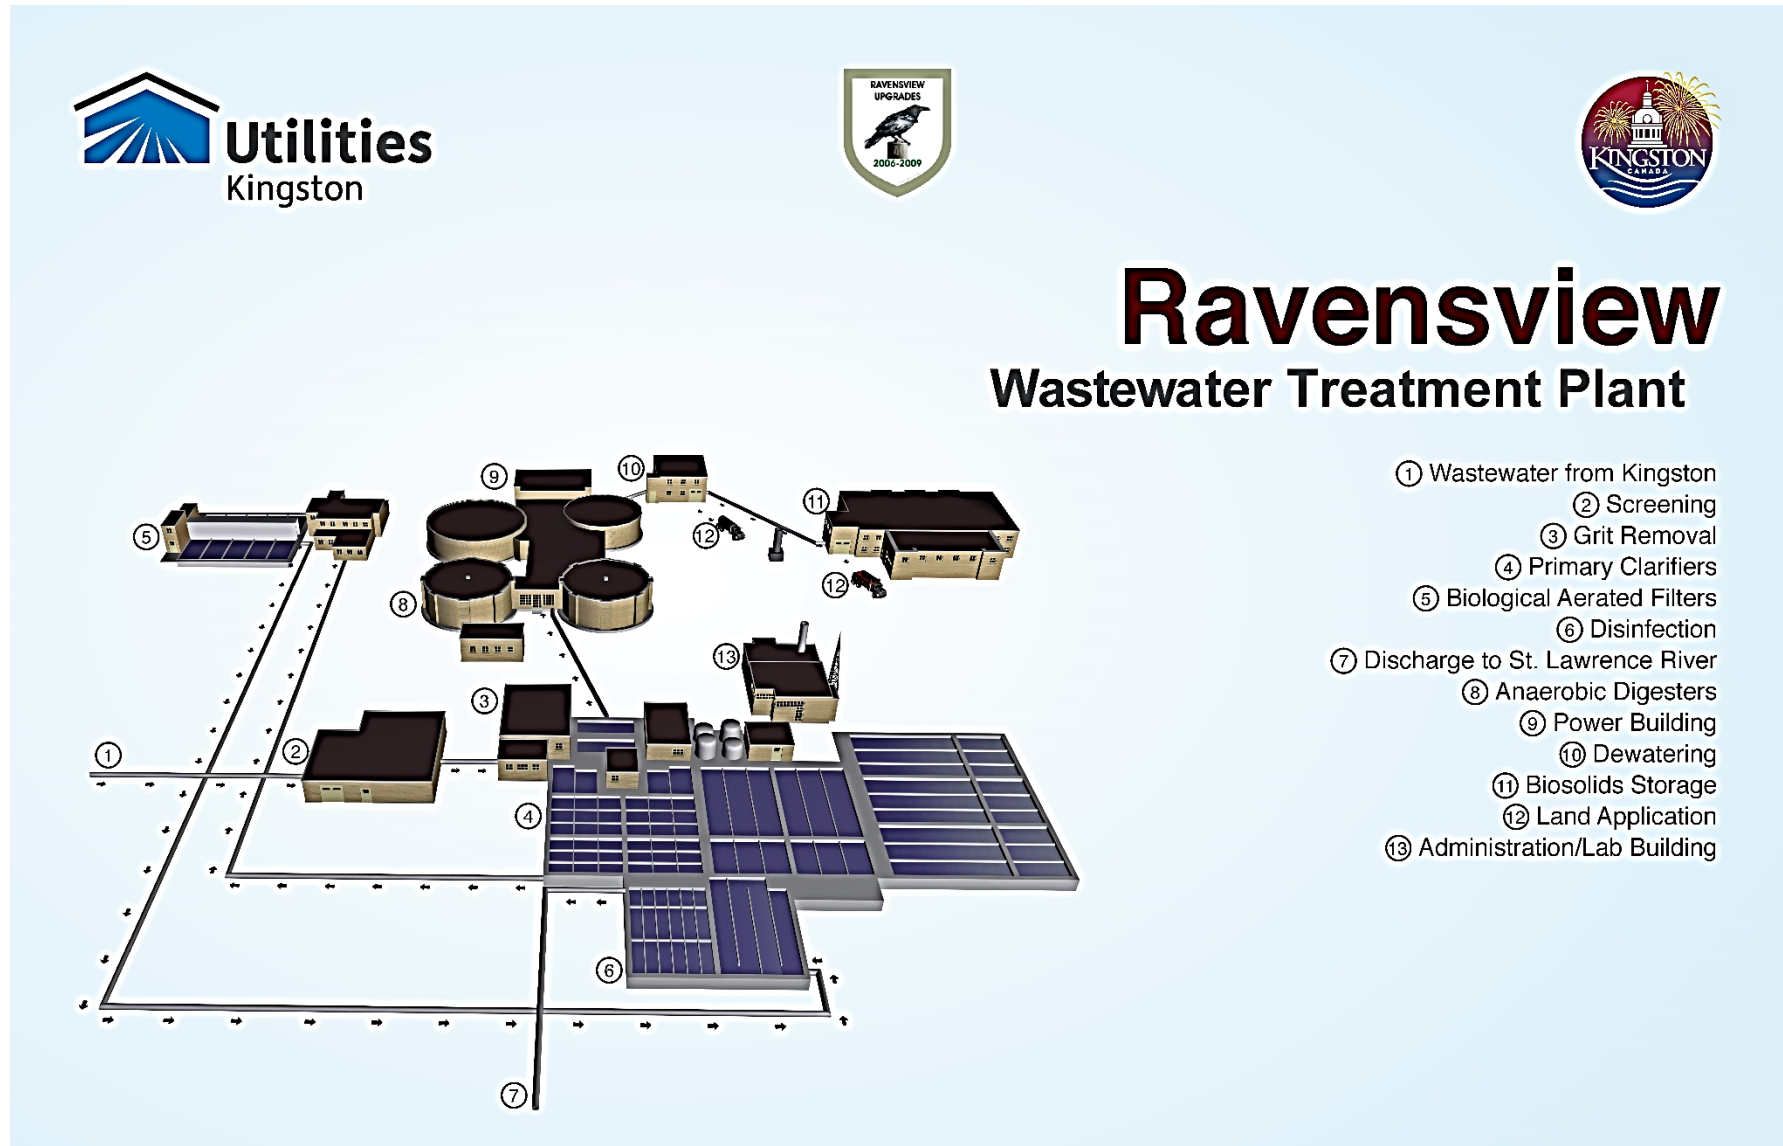
FIGURE 1 - RAVENSVIEW WASTEWATER TREATMENT PLANT GENERAL LAYOUT

Ravensview Wastewater Treatment Plant

- ① Wastewater from Kingston
- ② Screening
- ③ Grit Removal
- ④ Primary Clarifiers
- ⑤ Biological Aerated Filters
- ⑥ Disinfection
- ⑦ Discharge to St. Lawrence River
- ⑧ Anaerobic Digesters
- ⑨ Power Building
- ⑩ Dewatering
- ⑪ Biosolids Storage
- ⑫ Land Application
- ⑬ Administration/Lab Building

The following is a process overview and description of the treatment steps taken at Ravensview Wastewater Treatment Plant
